ROYAL COMMISSION
QUEBEC BRIDGE INQUIRY
REPORT

REPORT ON DESIGN OF QUEBEC BRIDGE
BY
C. C. SCHNEIDER

The Royal Commission appointed by commission dated the thirty-first day of August, A.D. 1907, to inquire into the cause of the collapse of the Quebec bridge, begs to present its report as follows:—

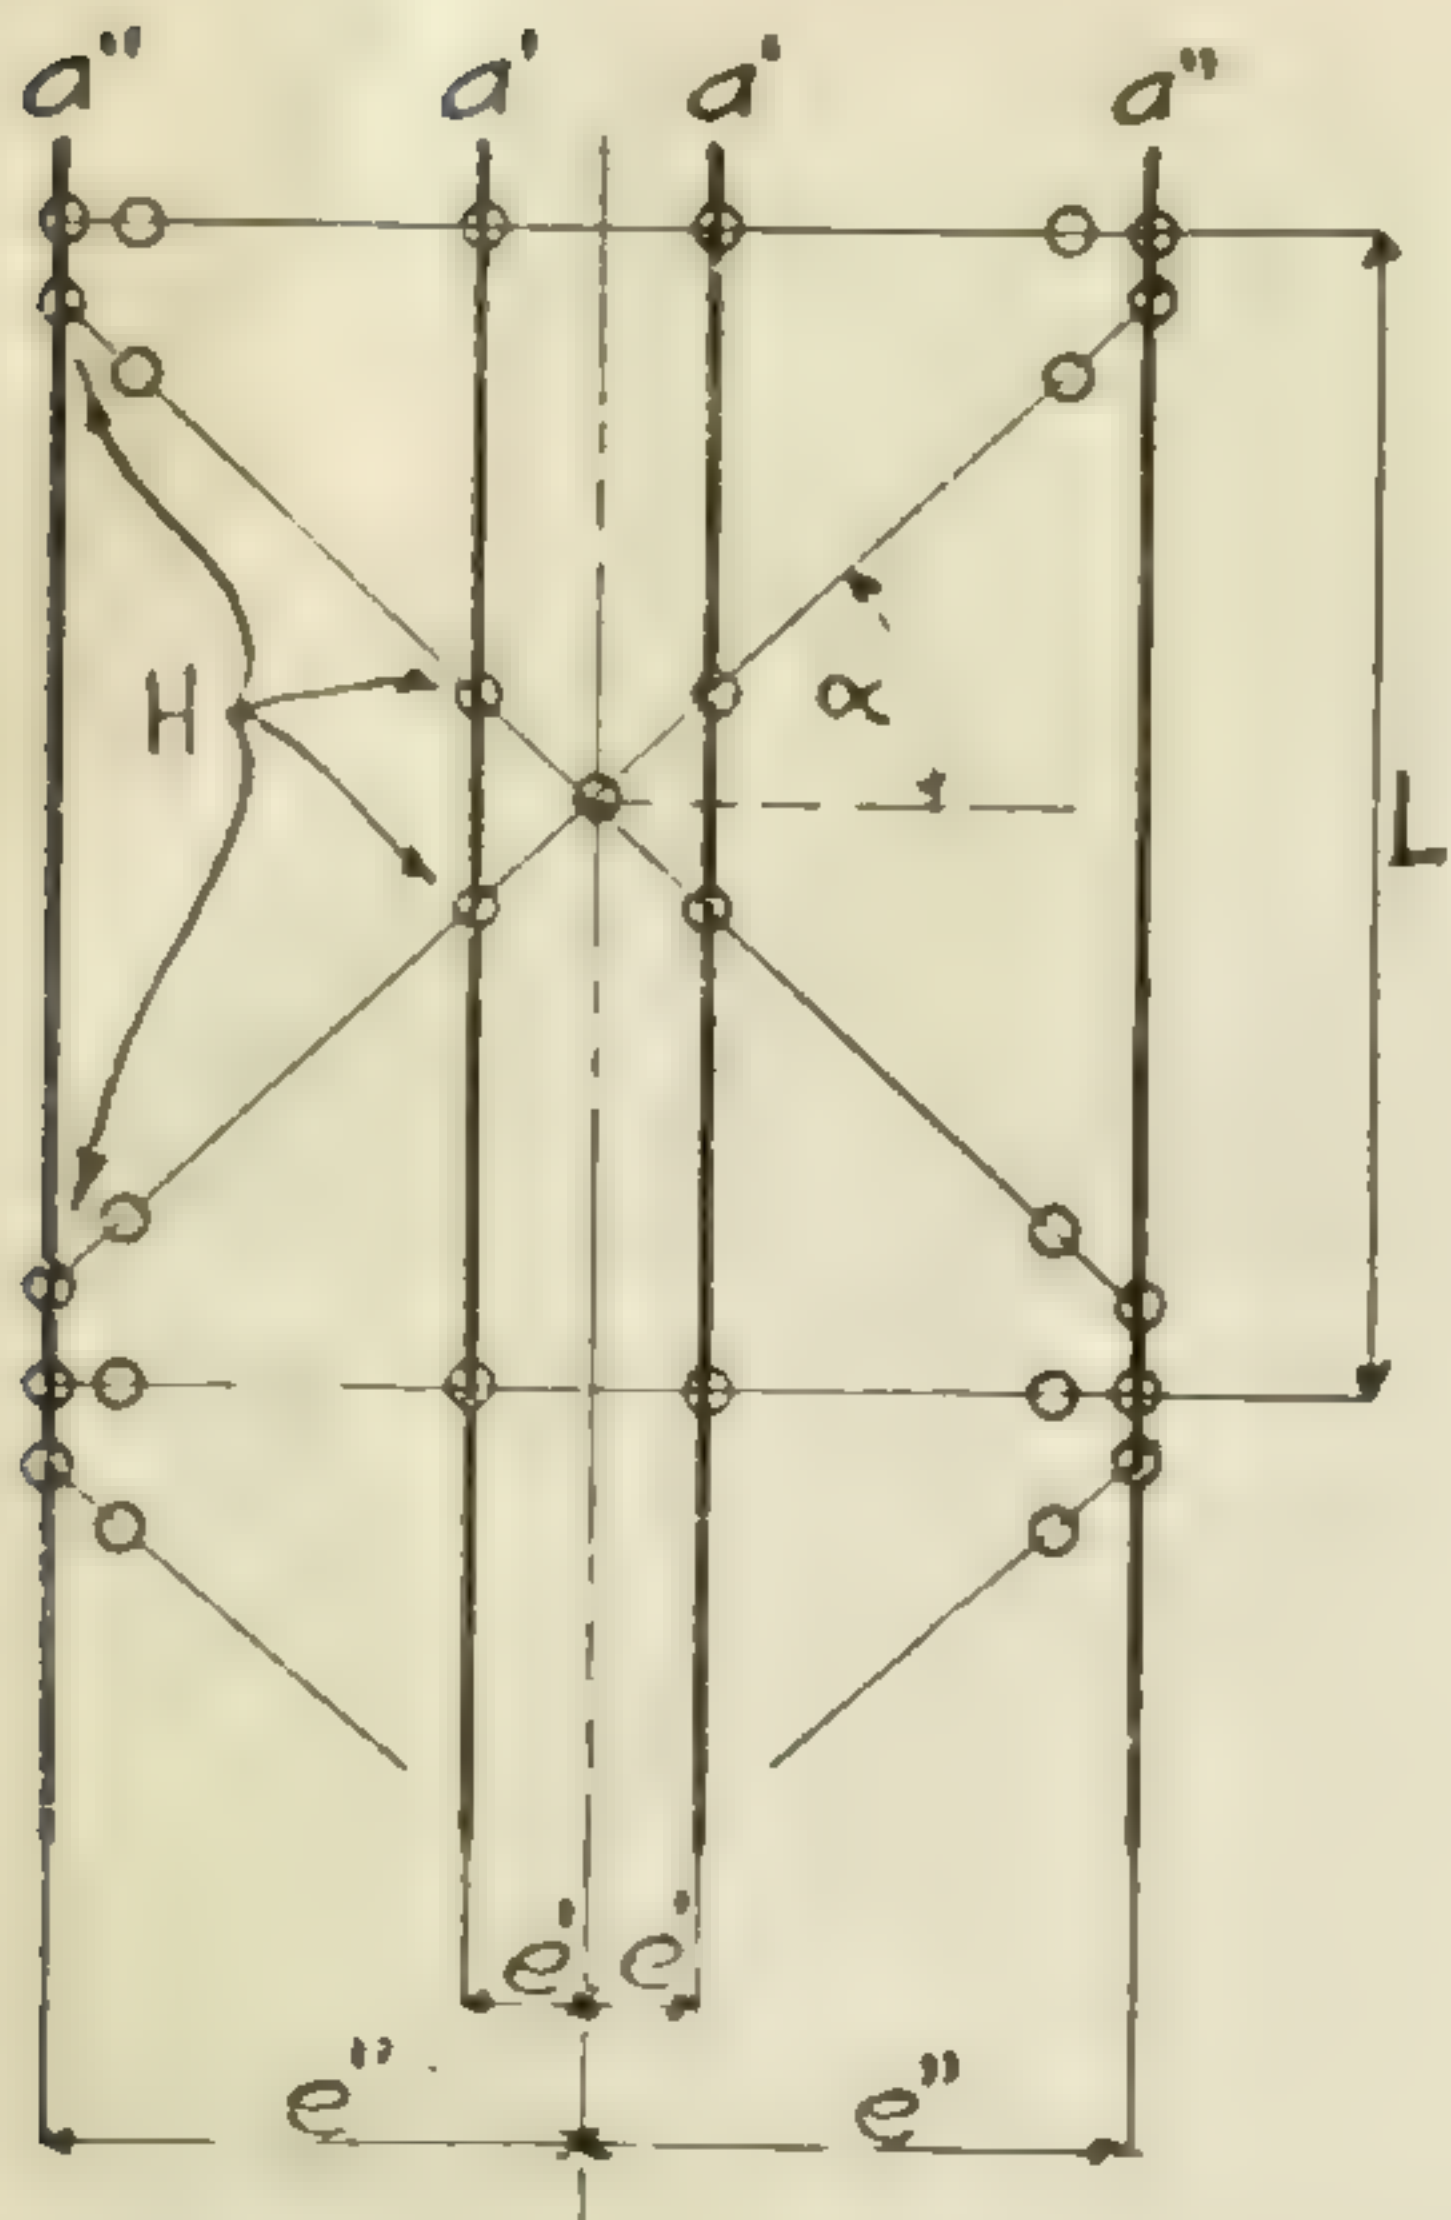
Fig. 21.

LATTICING OF THE LOWER CHORD (L-9) OF THE QUEBEC BRIDGE.

The top latticing as sketched in Fig. 21 (the circles indicating rivets) will first be considered.

The latticing angles between the outer and inner web practically form a complete system, only insignificant bending on the ribs being caused by the centre lines of the diagonals not meeting at the centre line of the ribs. We can apply formula (8) on page 198, to find the area which would be required in these angles, assuming hinges at points *H*.
